OBSERVATIONS OF MEGALUG® MECHANICAL JOINT RESTRAINTS IN CORROSIVE ENVIRONMENTS

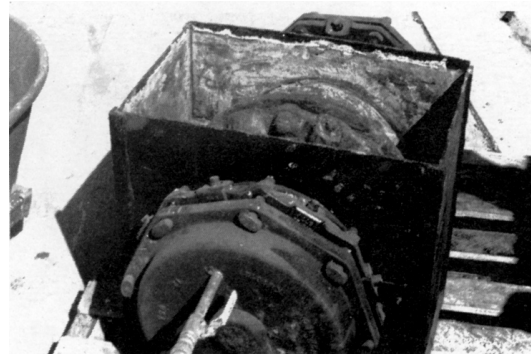
After a year, the test section was uncovered for observation. The gland, the pipe bell, and the bolts on the top half of the pipe had a tightly adherent scaly buildup. The bottom half had less of a buildup than the top. The scale made the parts appear very pitted and corroded. It was determined that the restraint, the pipe, and the T-bolts had graphitized. The iron ions had been leached out into the sand and the graphite structure remained. This was evidenced by the rusty color of the sand near the gland and pipe. The graphite was removed by blasting the mechanical joint. After the joint had been blasted, it was obvious that the top portion of the test section, restraint, pipe, and T-bolts, had been subjected to severe corrosive attack as evidenced by some large pits. The T-bolts that had been at or near the top of the joint had large sections corroded away. The lower half of the gland and pipe bell as well as the T-bolts were less severely attacked. The restraint gland and the pipe bell appeared to have a similar amount of pitting. The plain end pipe had some pitting but not as great as the bell and the gland. The pitting was much less extensive on the lower portion of the test section.

Finally, the joint was disassembled and the gland removed from the pipe. The marks on the pipe made by the wedges were still shiny, indicating little to no corrosive attack. The wedges did have some pitting, primarily towards the back. All the wedges remained in firm contact with the pipe and the test section remained pressurized.

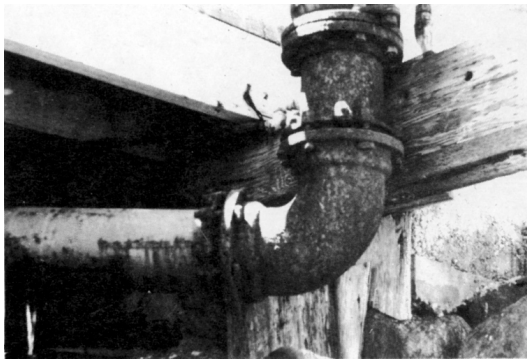
The fitting, pipe sections, and the MEGALUG restraints seemed to have quite a severe buildup of corrosion products. The most severe corrosion appeared to be on the flanged pipe. Removal of the corrosion layer on the elbow and the pipe sections revealed fairly uniform corrosion with some severe pitting. The MEGALUG glands and the bolts were covered with small pits; however, the lettering on the glands was still legible. The T-bolts on the plain end pipe could be loosened with a socket wrench. Two of these bolts broke during disassembly. The T-bolts on the flanged pipe had to be cut off. The glands were cut off both pipe sections to minimize the disturbance of the corrosion products.

There was a relatively large amount of corrosion product on the area of the pipes under the glands. The area under the MEGALUG restraint's gripping wedges showed quite a bit of corrosive build-up although the points of contact were shiny. The sample was then sent to an outside laboratory for analysis.

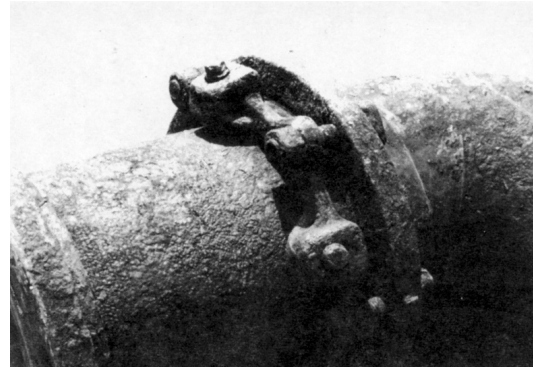
The laboratory analysis concluded that the sample had undergone corrosive attack due to exposure to a chloride environment. In addition, the laboratory report stated that the build up of corrosion products was most likely uniform but that the products were allowed to flake away from the fitting and part of the pipe surface due to the washing action of the salt water spray. The other corrosion products were held

in place on the pipe surface immediately under the restraint gland. The analysis also indicated that the pipe surface was subject to a uniform corrosion and that the MEGALUG restraint **did not** accelerate the corrosion at the point of contact. "Examination of the cross-section at and away from the contact point disclosed a remaining wall thickness of 0.383 inches... This indicates a uniform corrosive attack of the entire flange pipe surface with no indication of acceleration attack at the flange pipe and mega lug [sic.] gland contact point."

As mentioned above, the MEGALUG is made of ductile iron just as the pipe and fittings are. By using similar materials, the risk of galvanic corrosion is reduced. However, ductile iron is still susceptible to galvanic corrosion and may need some type of corrosion protection. Connections™ bulletins GI-1, GI-2, and GI-3 provide some tips for reducing corrosion.
